## D3.5: Influence of passive film on the corrosion behaviour of the HEA coating

## REVISION HISTORY

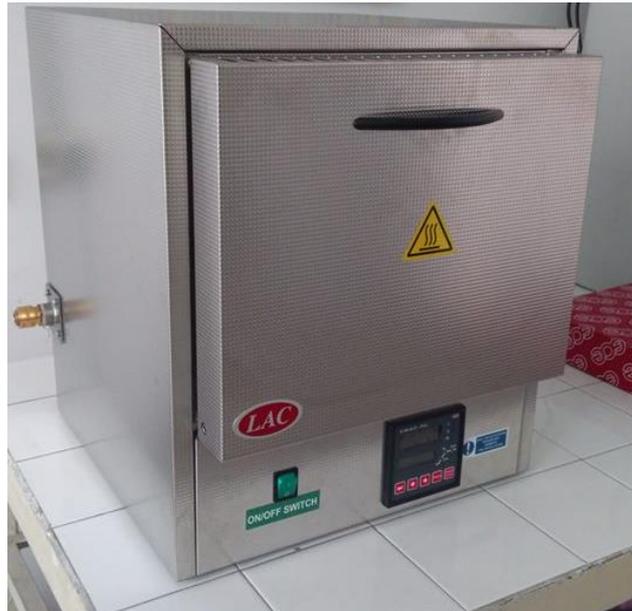
**Figure 1:** Furnace used for heat treatment of the HEA coated samples

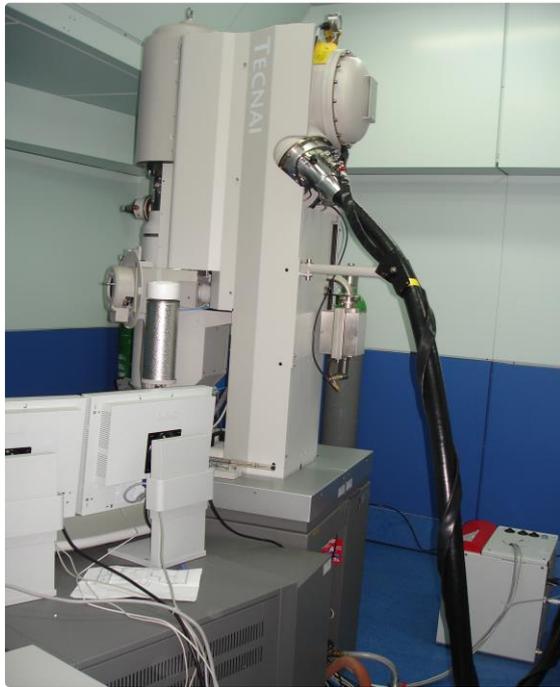
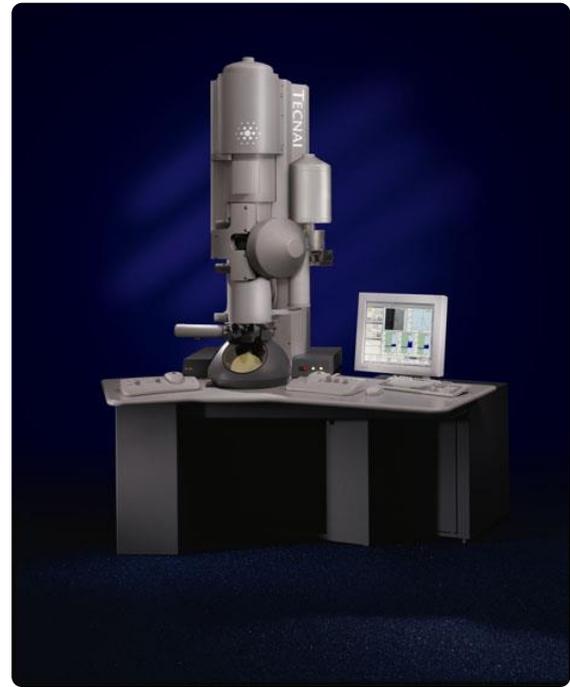
**Figure 2:** The METAV TEM equipment - Tecnai G2 F30S-TWIN Quanta, equipped with energy-dispersive x-ray spectroscopy (EDX) and electron energy-loss spectroscopy (EELS)

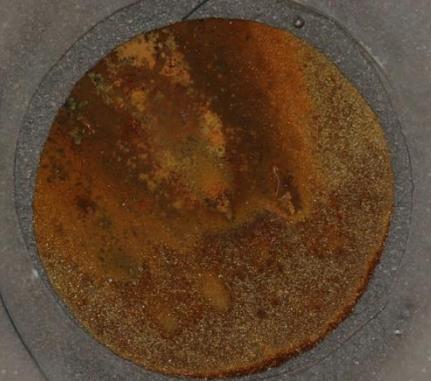
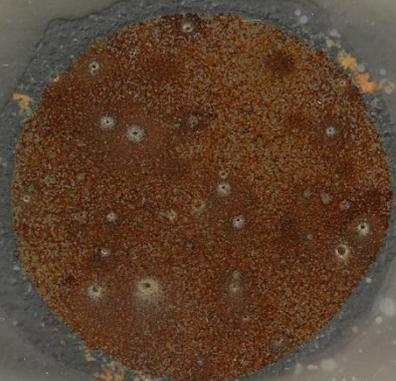
coating flaked off during preparation
HVOF - HEA4 - S4	HVOF - HEA4 - S4 - HT1	HVOF - HEA4 - S4 - HT2

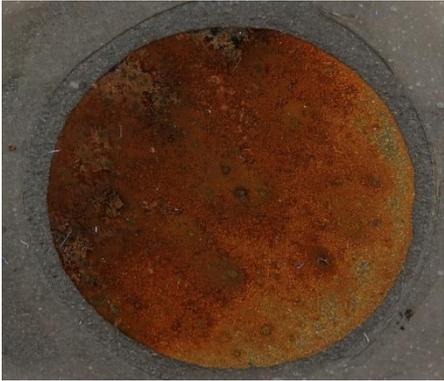
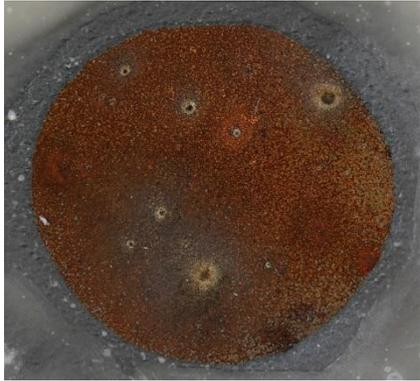
coating flaked off during preparation
LC - HEA1 - S1	LC - HEA1 - S1 -HT1	LC - HEA1 - S1 -HT2

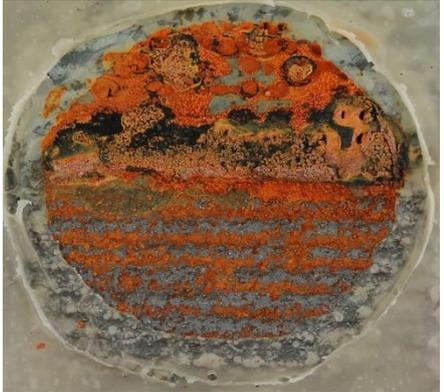
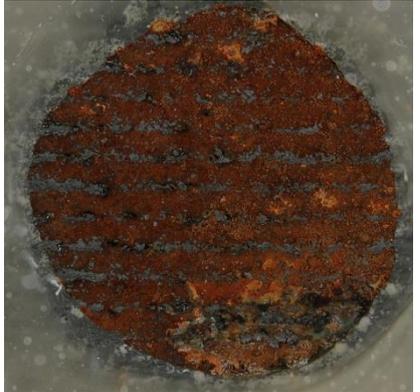
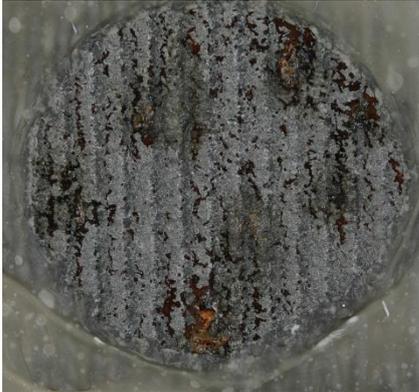
LC - HEA4 - S1	LC - HEA4 - S1 -HT1	LC - HEA4 - S1 -HT2

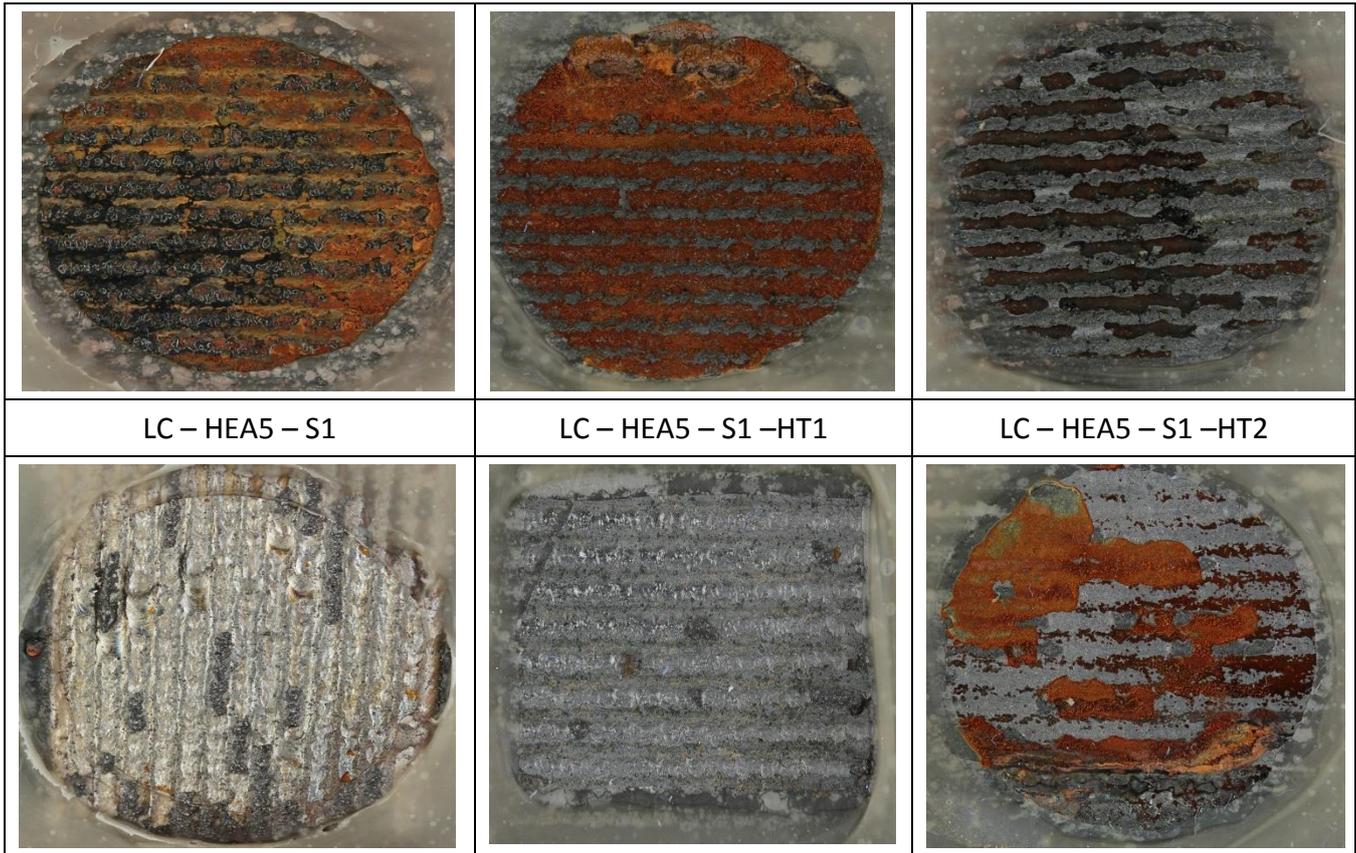
As it can be seen from the photographs, two of the specimens, HVOF-HEA3-S4-HT2 and HVOF-HEA4-S4-HT2 could not be tested as the coating flaked off during the preparation operations for electrochemical testing. This is likely due to build-up of stress during the heating cycle due to the difference in coefficient of thermal expansion (CTE) between the deposited coating and substrate. This demonstrates the poor adhesion properties of these two coatings and it has therefore been decided to not further proceed with their analysis. It is worth nothing how a clear improvement in corrosion properties is only observed for specimen HVOF-HEA2, while no clear conclusions can be deduced after visual observation. The corrosion rates calculated for the specimens tested are reported in Table 5 and a visual representation is reported in Figures 3 and 4.

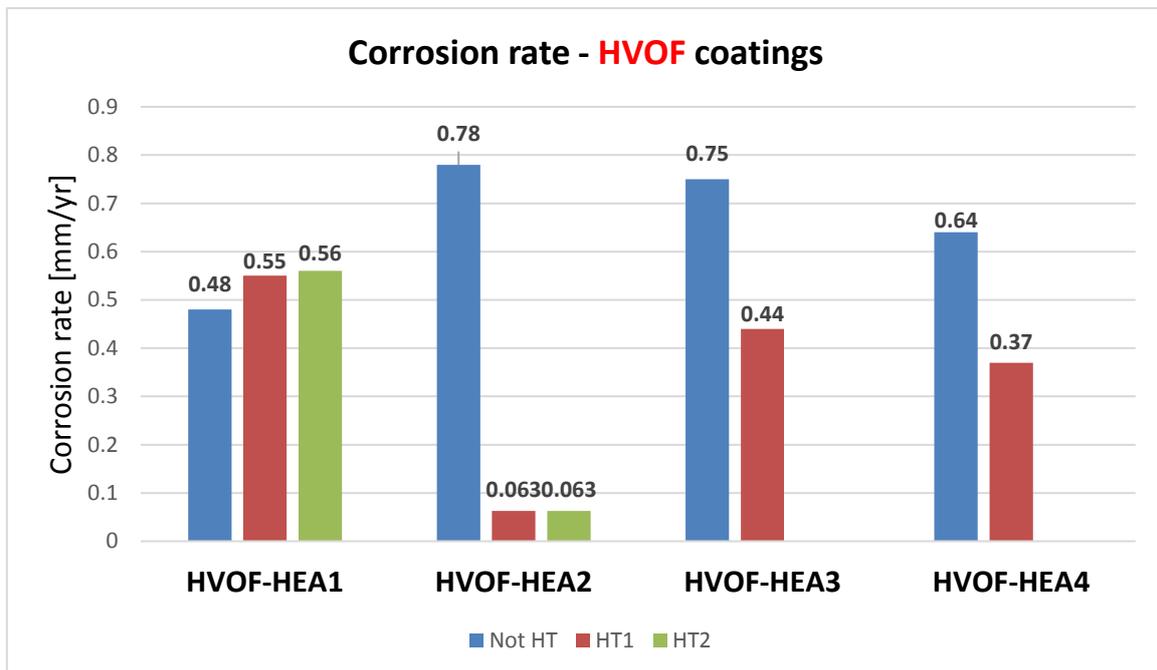
**Figure 3:** Corrosion rate results for HVOF coated samples

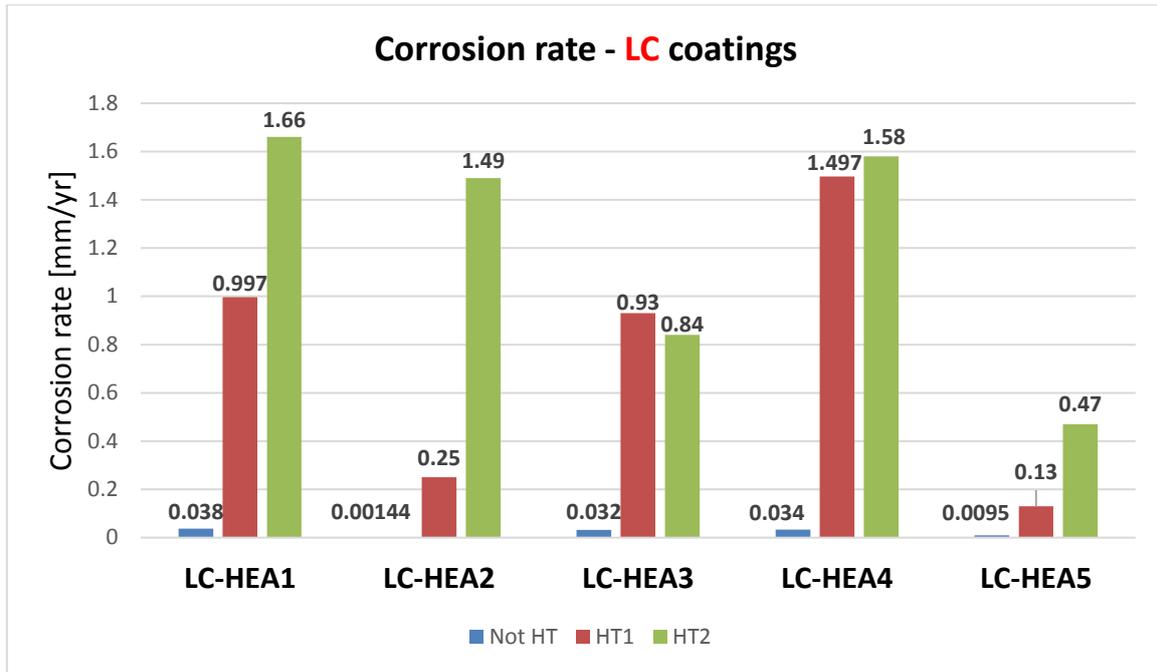
**Figure 4:** Corrosion rate results for the LC coated samples.

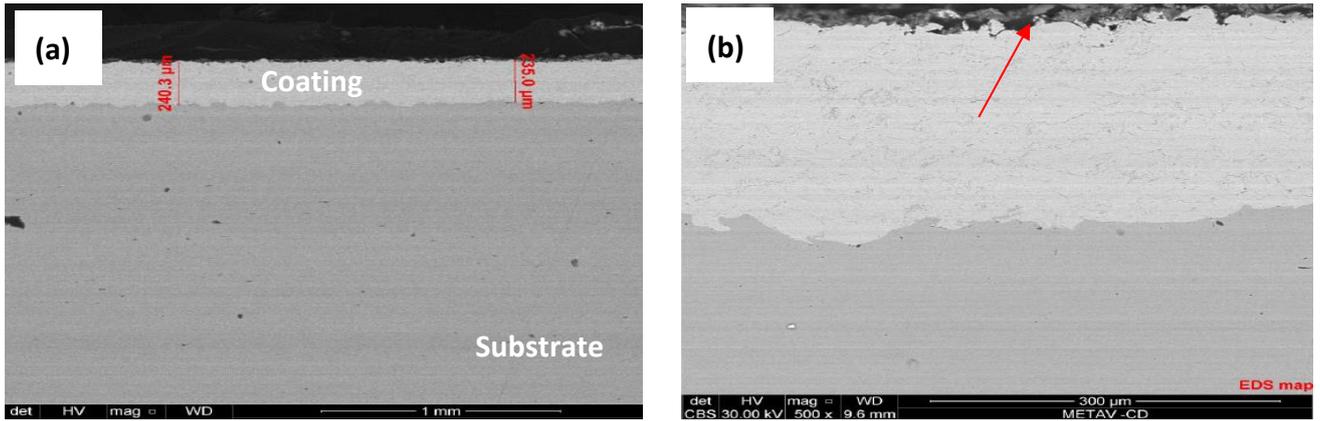
**Figure 9:** SEM micrographs showing the HEA deposition sample in cross section and the interface of the specimen at (a) low and (b) high magnification.

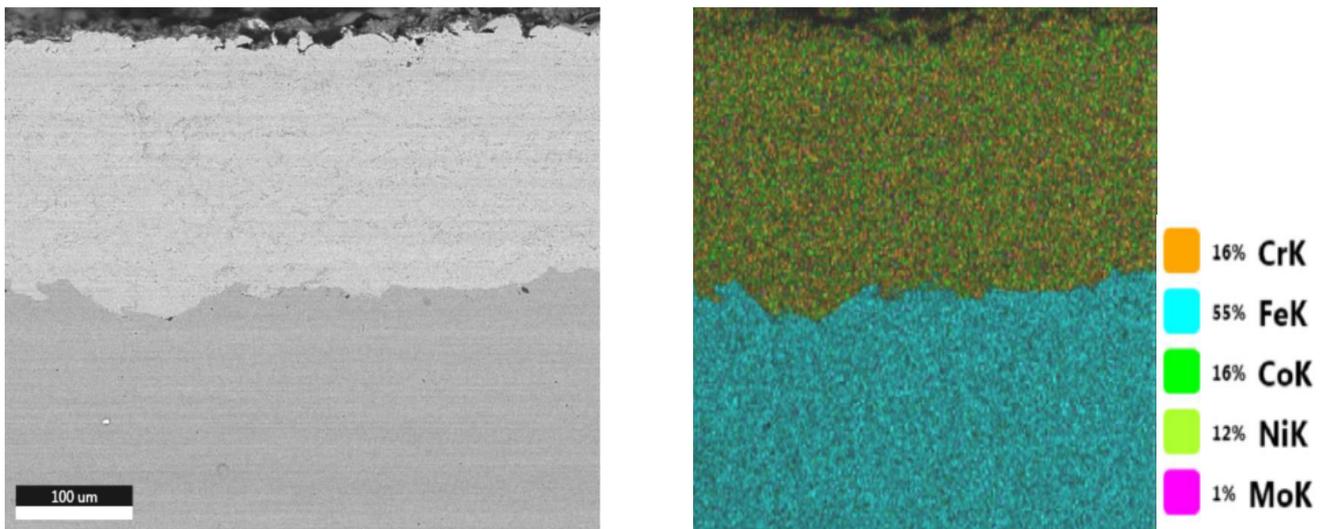
**Document:** D3.5: Influence of passive film on the corrosion behavior of the HEA coating  
**Version:** 01  
**Date:** 31 July 2019

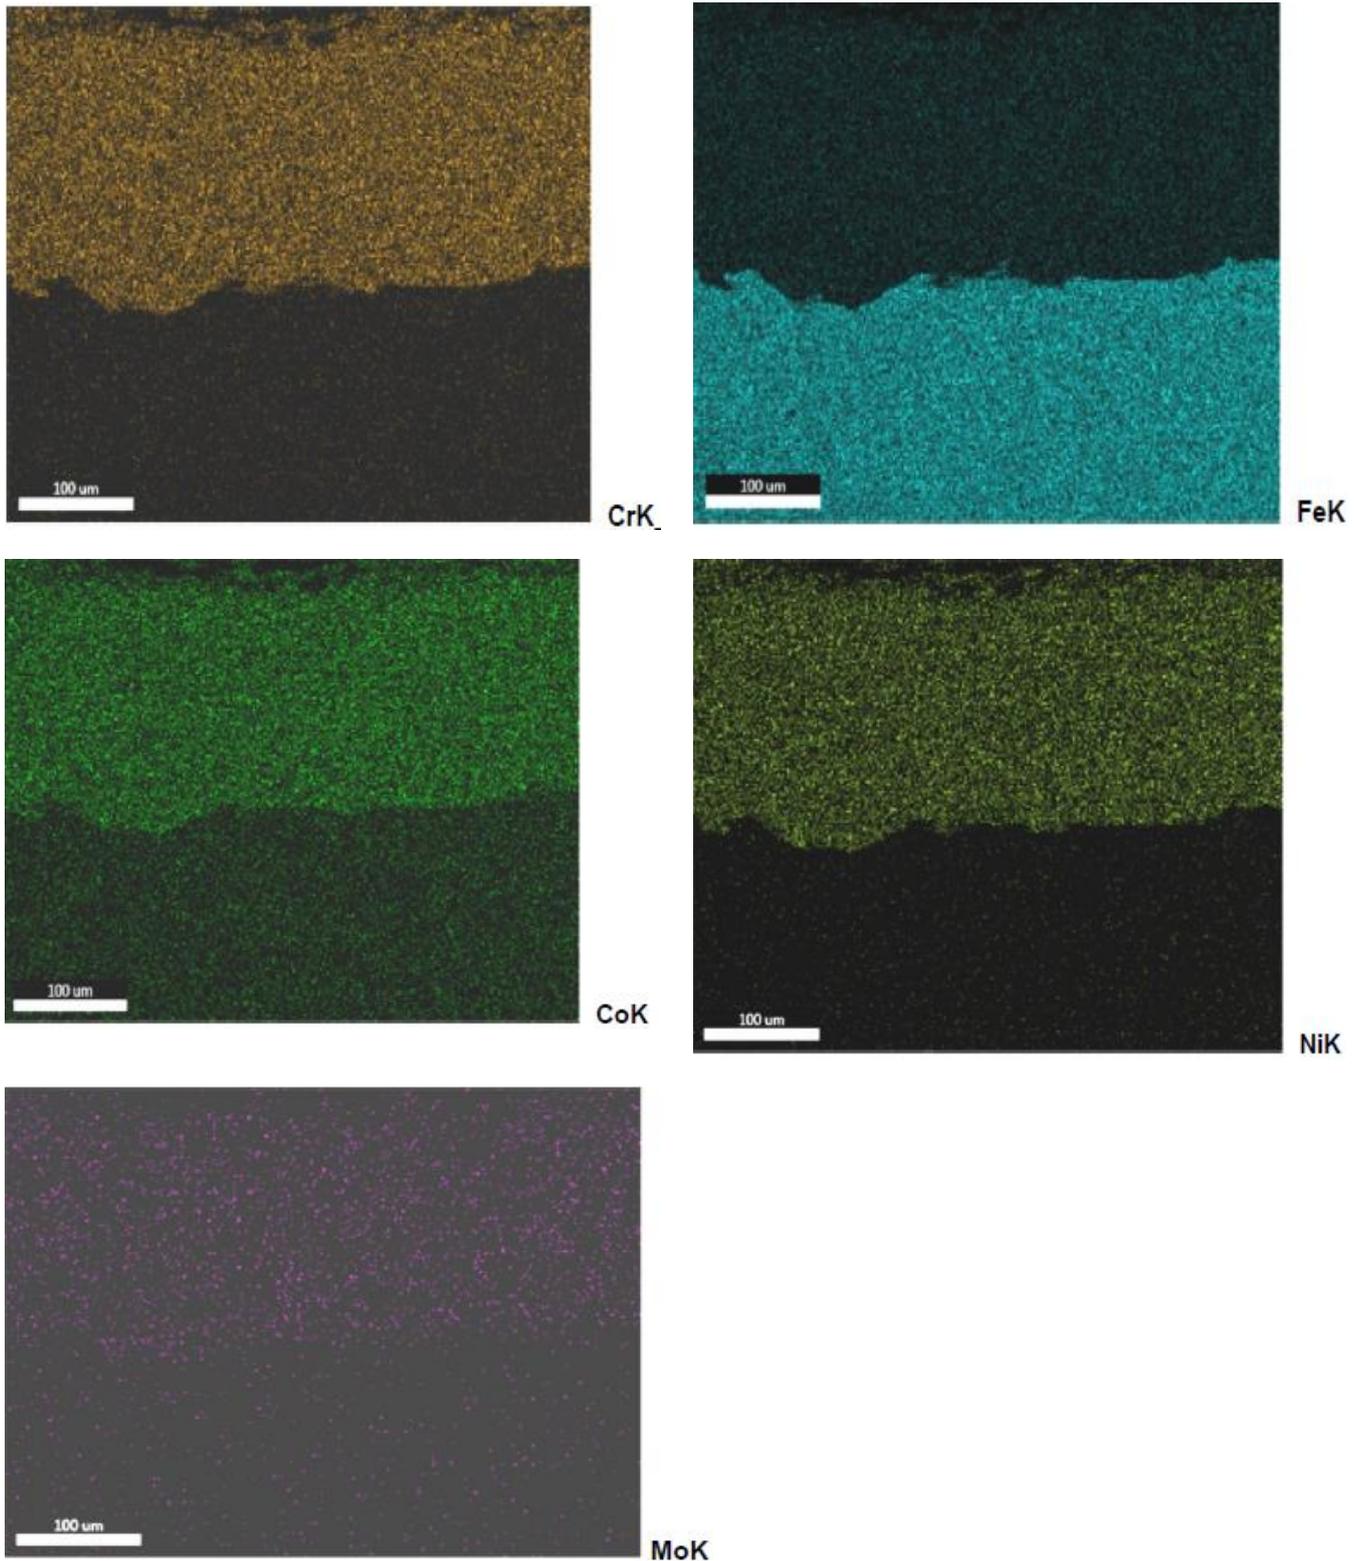
**Figure 10:** SEM and EDX general analysis showing X-ray mapping for HEA elements and identification of disperse deposition of elements.

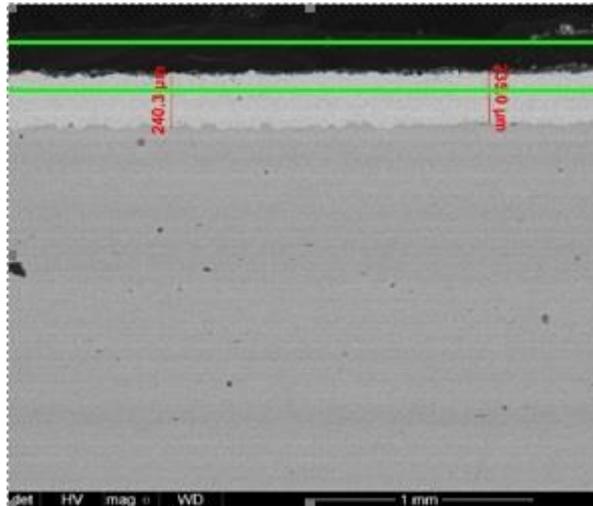
**Figure 11:** SEM micrograph showing the HEA deposition sample in the cross-section and indication of the area for TEM sample preparation in green.

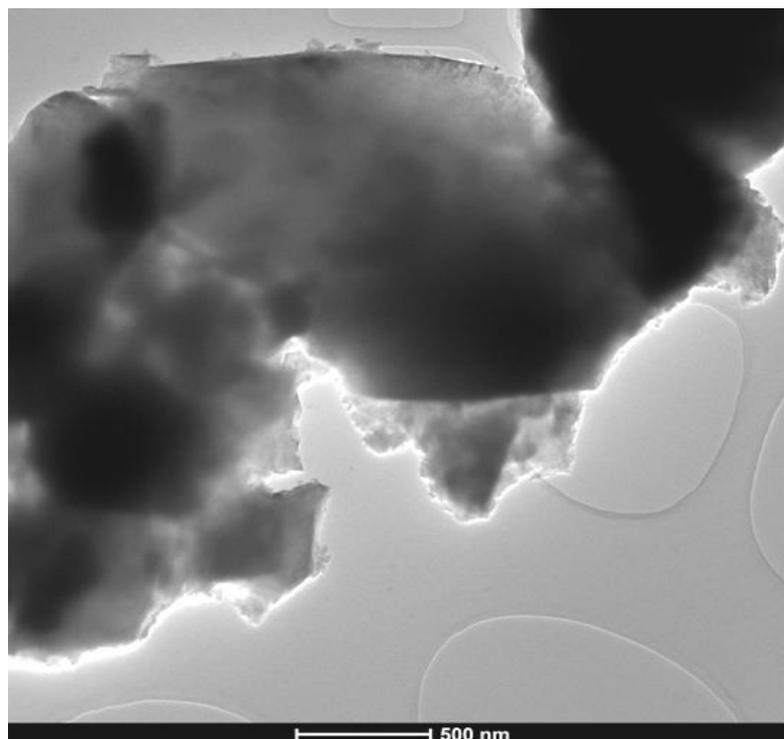
**Figure 12:** TEM micrograph of HVOF-HEA2 coating. The HEA alloy forming some micro constituent in specific areas.

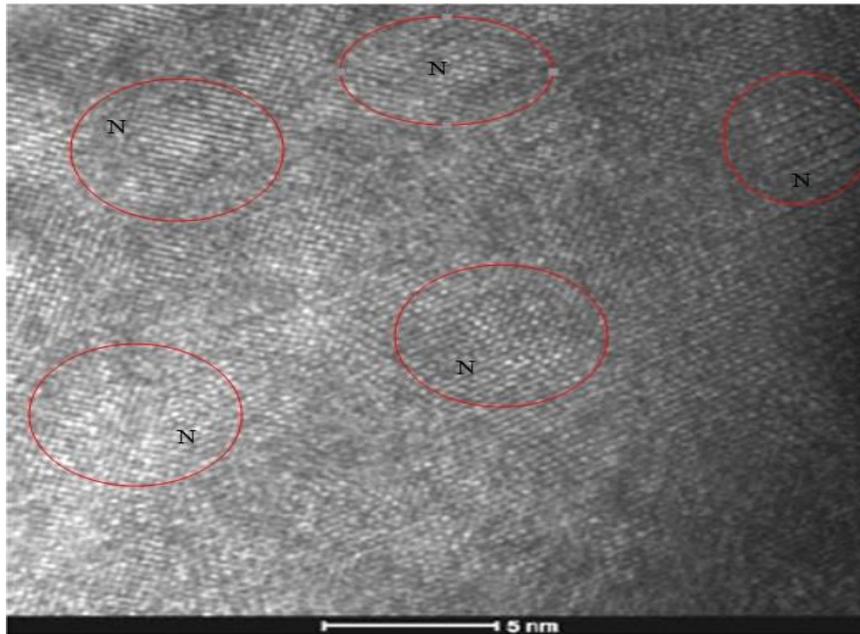
**Figure 15:** A typical HRTEM image with identified nanocrystalline precipitates (N domain). In figure it is seen that the nanocrystallites and same crystal orientation as the precipitates in the different region (magnification X 1.5 000 000).

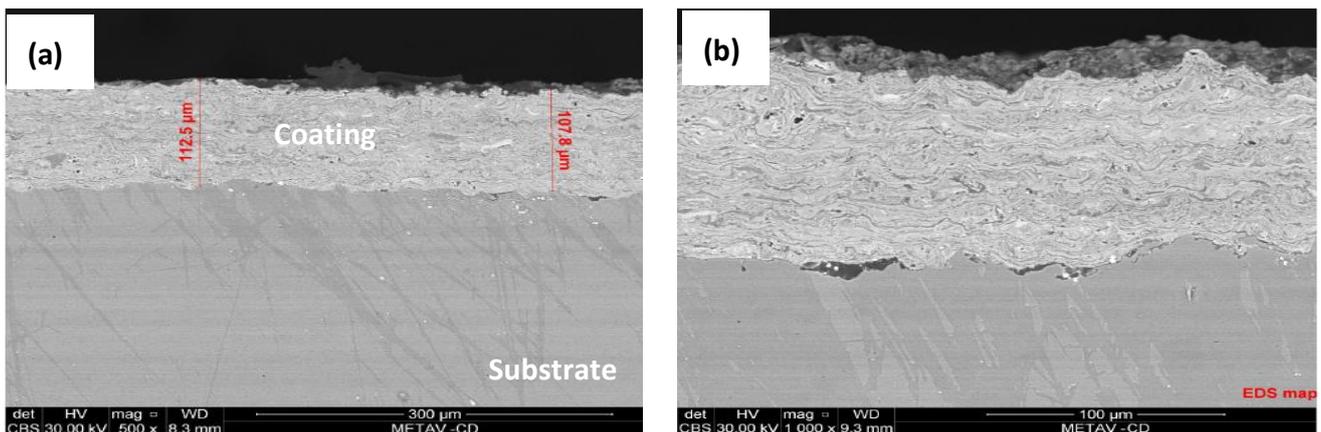
**Figure 18:** SEM micrographs showing sample HVOF-HEA2-HT2 in cross section.

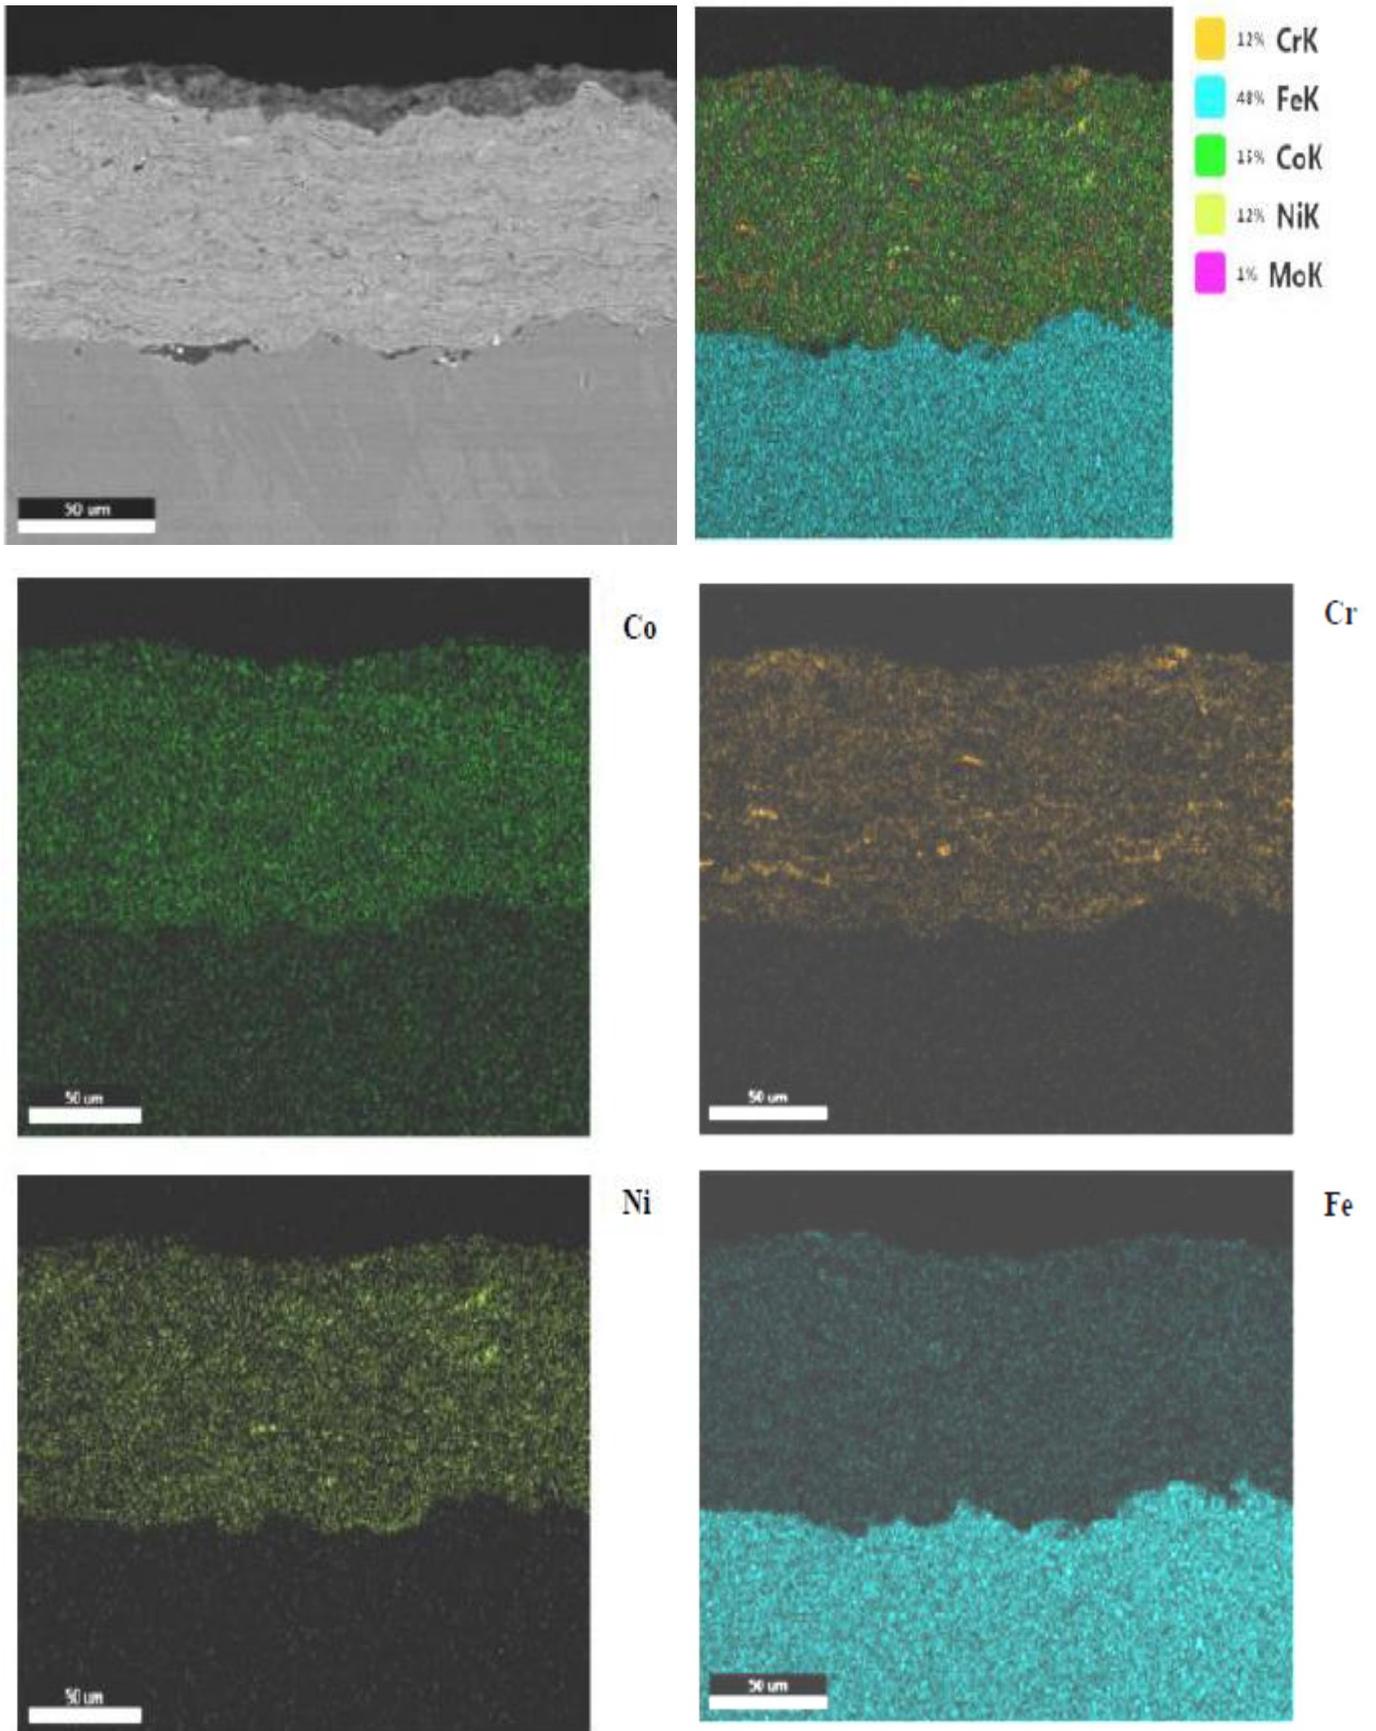
**Document:** D3.5: Influence of passive film on the corrosion behavior of the HEA coating  
**Version:** 01  
**Date:** 31 July 2019

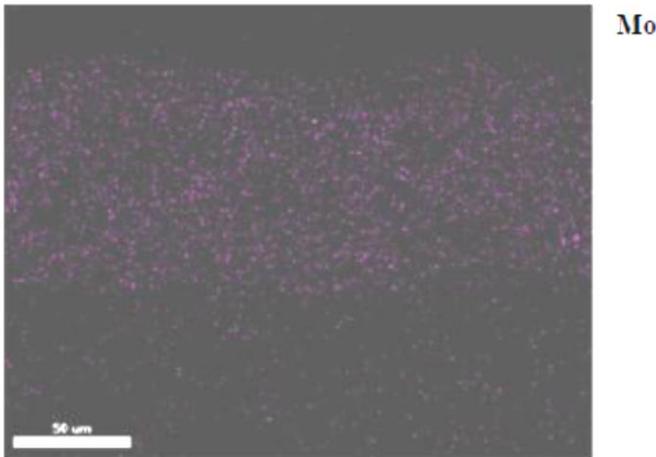
**Figure 19:** SEM-EDX analysis showing X-ray mapping for HEA elements and identification of disperse deposition of elements.

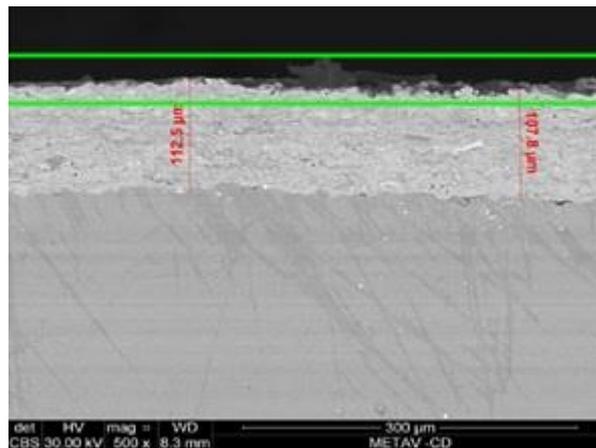
**Figure 20:** SEM micrograph showing the HEA deposition sample in the cross-section and indication of area for TEM sample preparation.

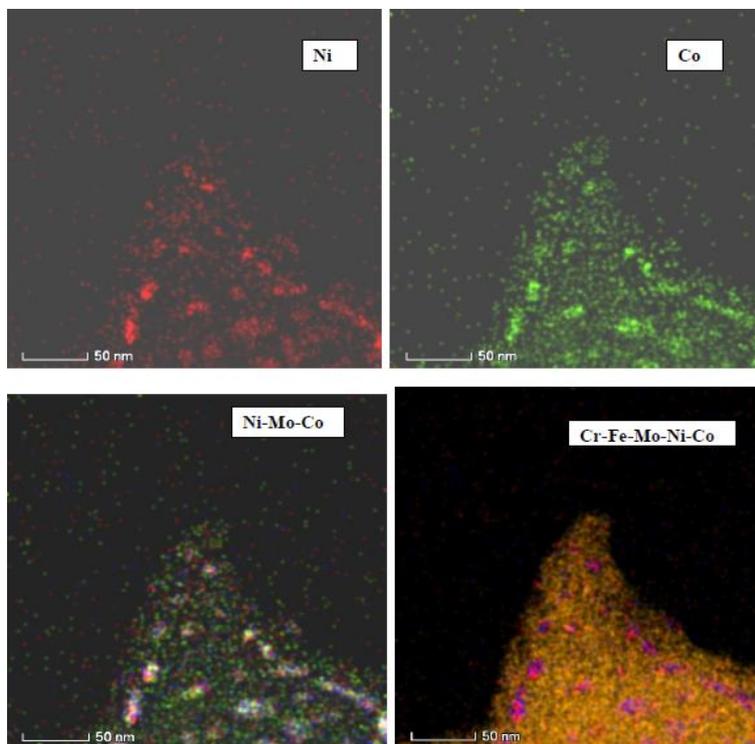
**Figure 24:** TEM mapping of HEA treated specimen showing the element distributions. Note a local area distribution of Ni-Co particle with complex HEA matrix.

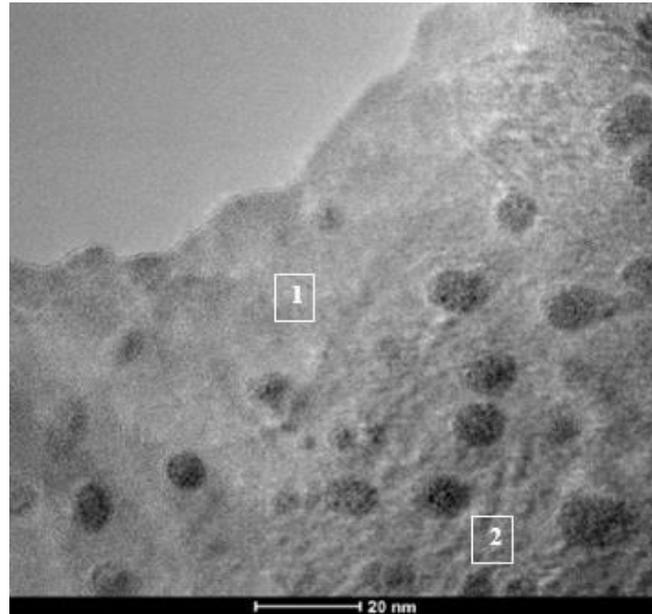
**Figure 25:** HRTEM image of nano-areas including nanostructure observed after treatment. There is an increase in nanoprecipitates Ni-Co\_Mo (1) and the micrograph showing inadaptible dislocation network (2) shearing no special orientation in the matrix (magnification X 800 000).

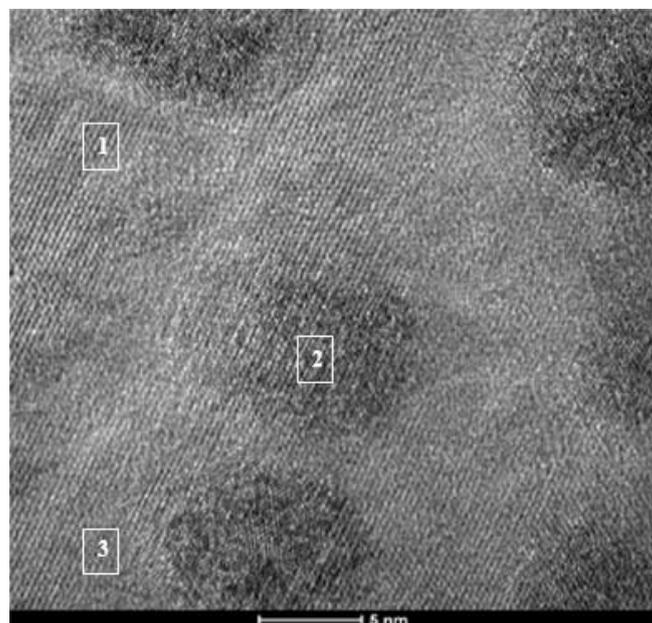
**Figure 26:** HRTEM image of nano-areas including images of homogeneity in the HEA crystallization (1) and structure nanoprecipitate (2) and dislocation networks (3) as response of the terminal treatment of samples (magnification X 1.5 000 000)

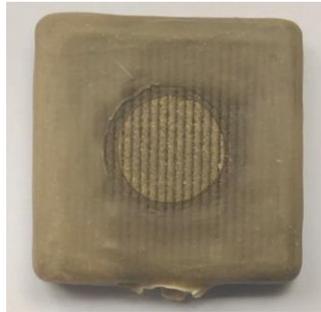
**Figure 28:** Cross-section through the LC deposition

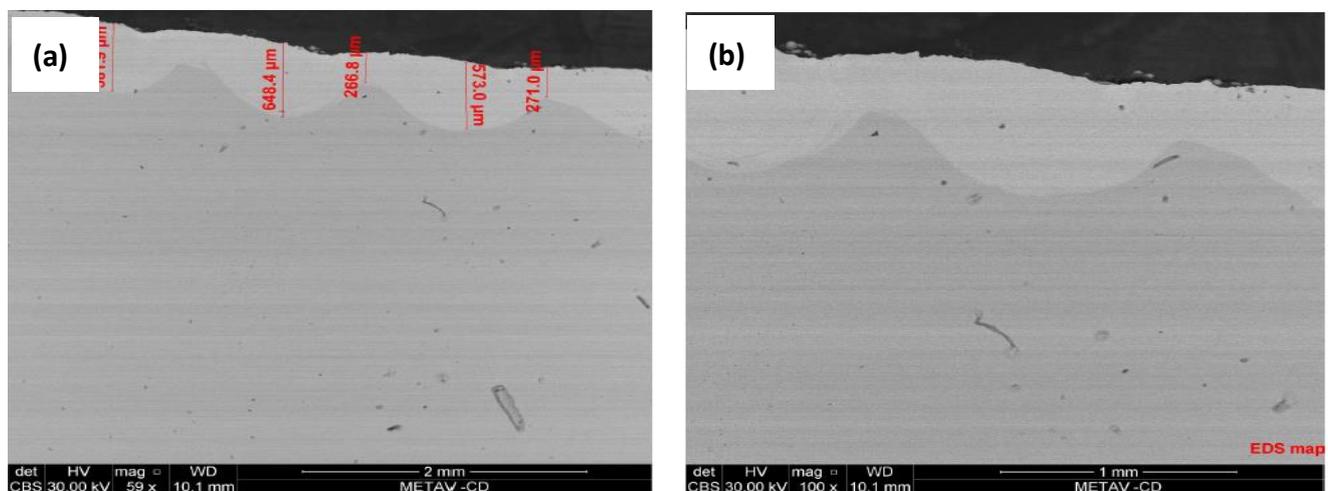
**Figure 29:** SEM micrographs showing the LC-HEA2 sample in cross section.

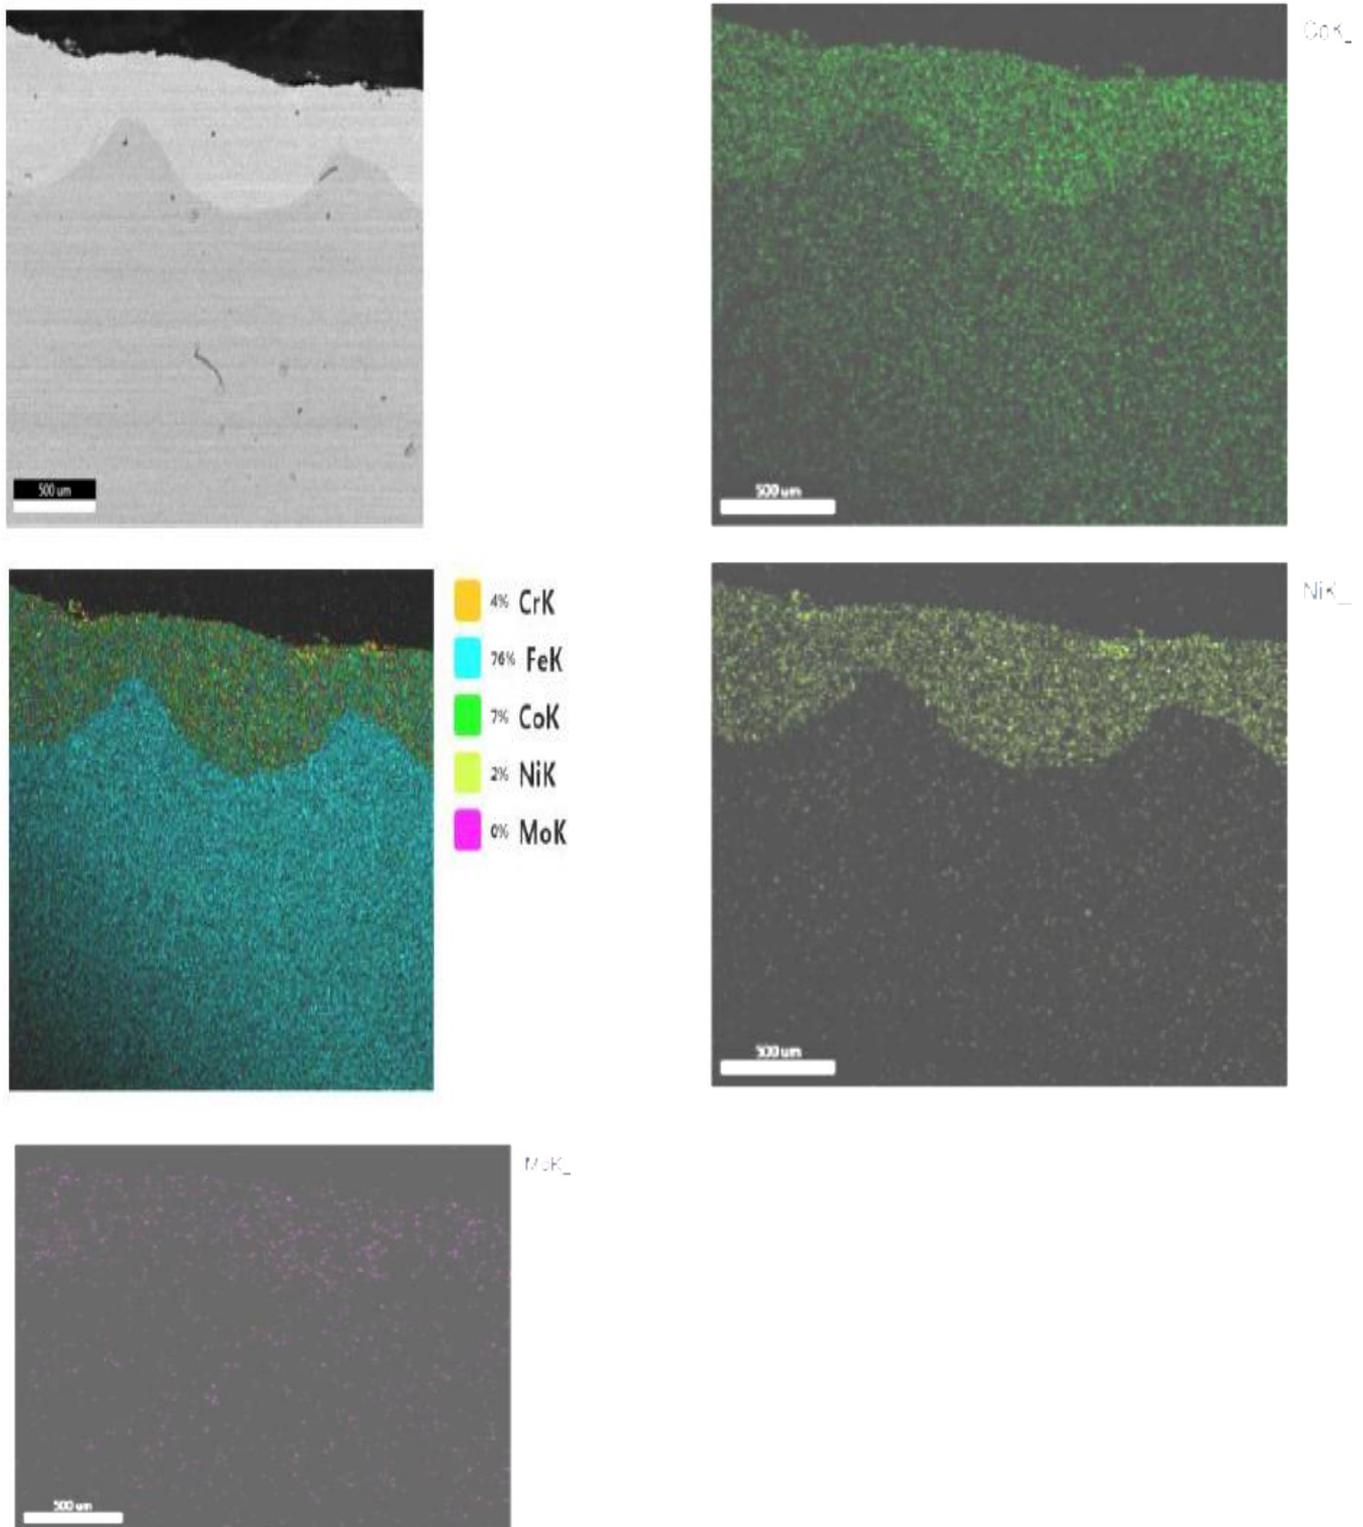
**Figure 30:** SEM and EDX general analysis showing X-ray mapping for HEA elements and identification of disperse deposition of elements.

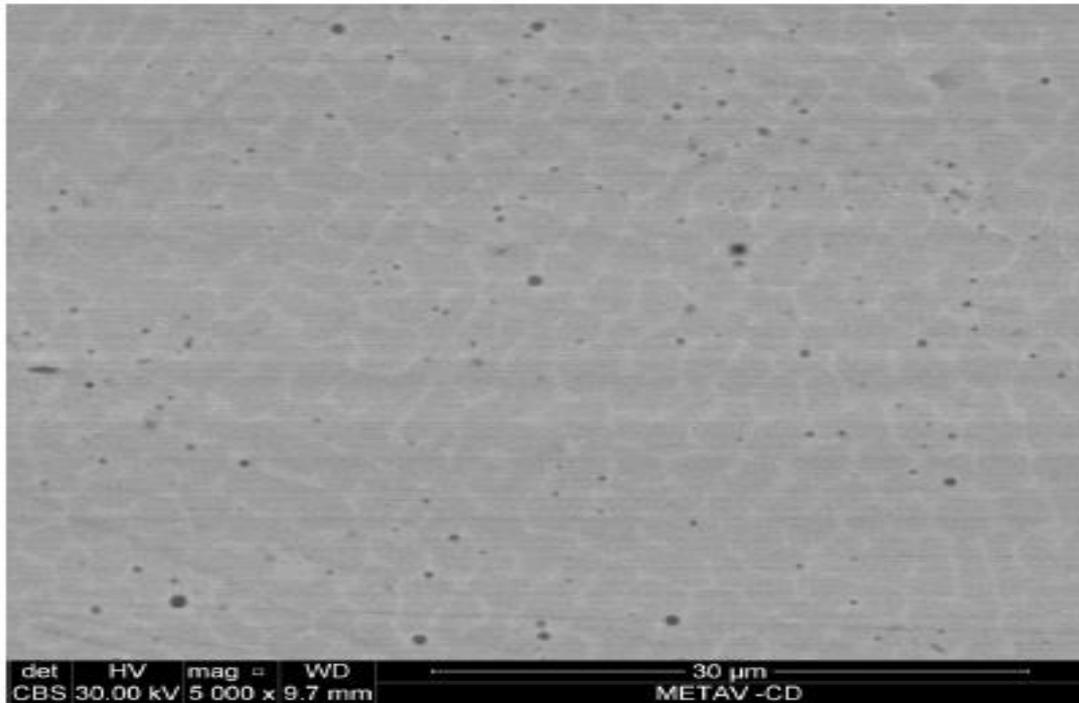
**Figure 31:** SEM backscattered image showing the microstructure of the clad LC-HEA2 alloy.

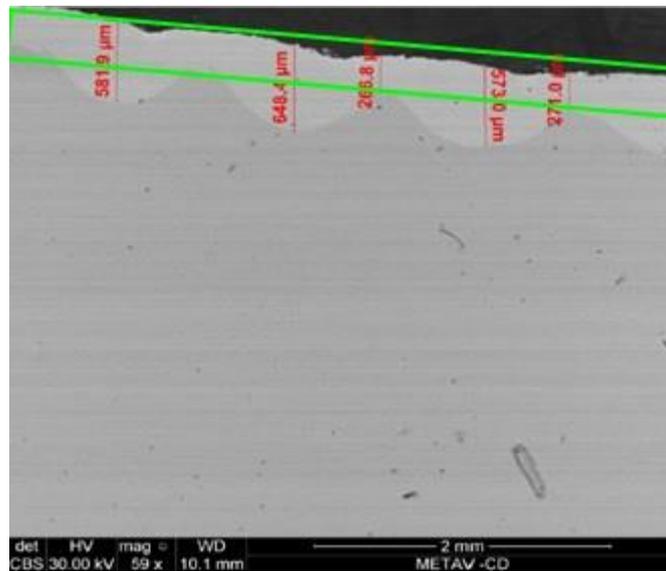
**Figure 32:** SEM micrograph showing the LC-HEA2 sample in the cross-section and indication of area for TEM sample preparation.

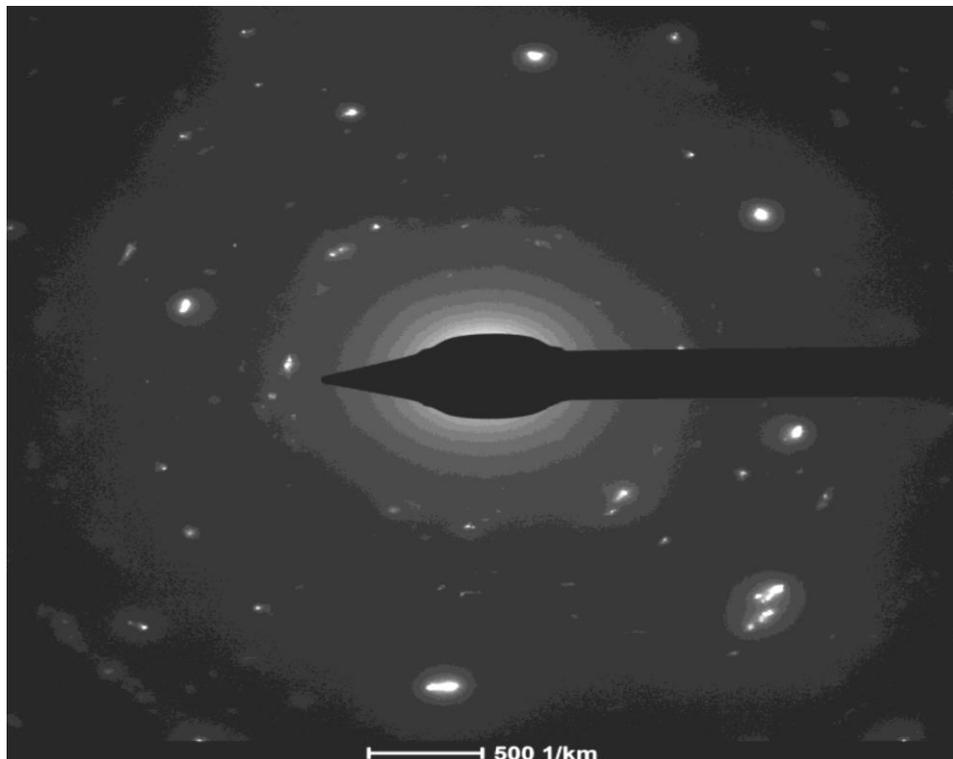
**Figure 34:** TEM Electron diffraction pattern show some microcrystals format as surface of deposition of HEA laser layer.

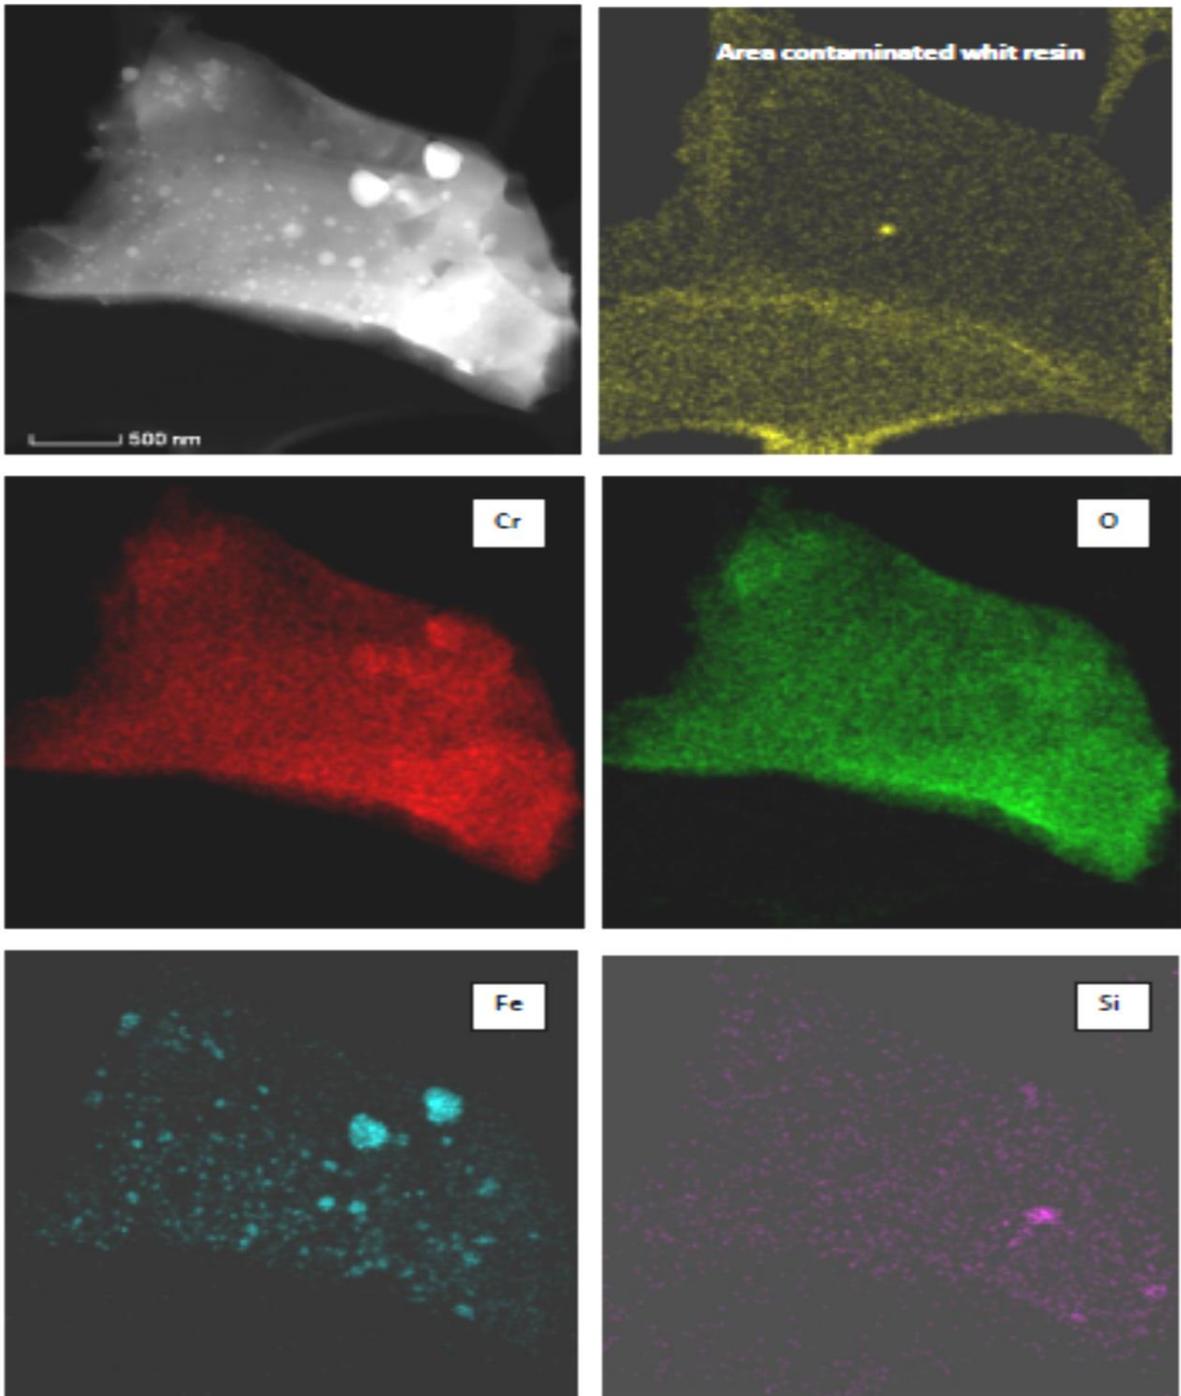
**Figure 35:** TEM-EDX mapping of HEA treated specimen showing the element distributions (Cr, O, Fe, Si) and the contaminated area with resin.

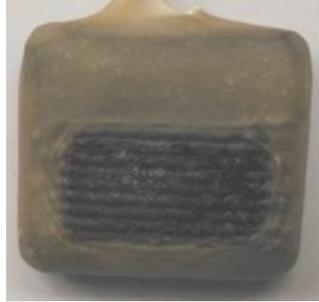
**Figure 36:** Surface photograph of specimen LC-HEA2-HT2 after exposure.

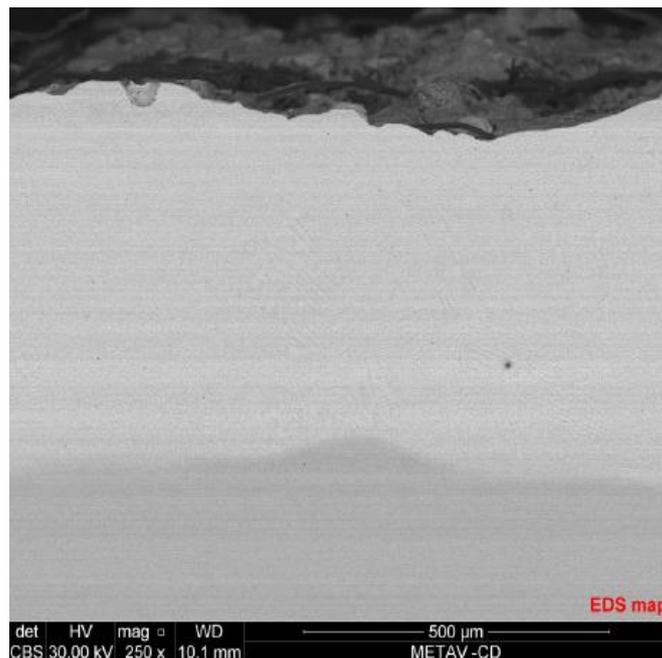
**Figure 37:** SEM micrograph showing the cross-section of specimen LC-HEA2-HT2 after exposure.
