## D3.5: Influence of passive film on the corrosion behaviour of the HEA coating

## REVISION HISTORY

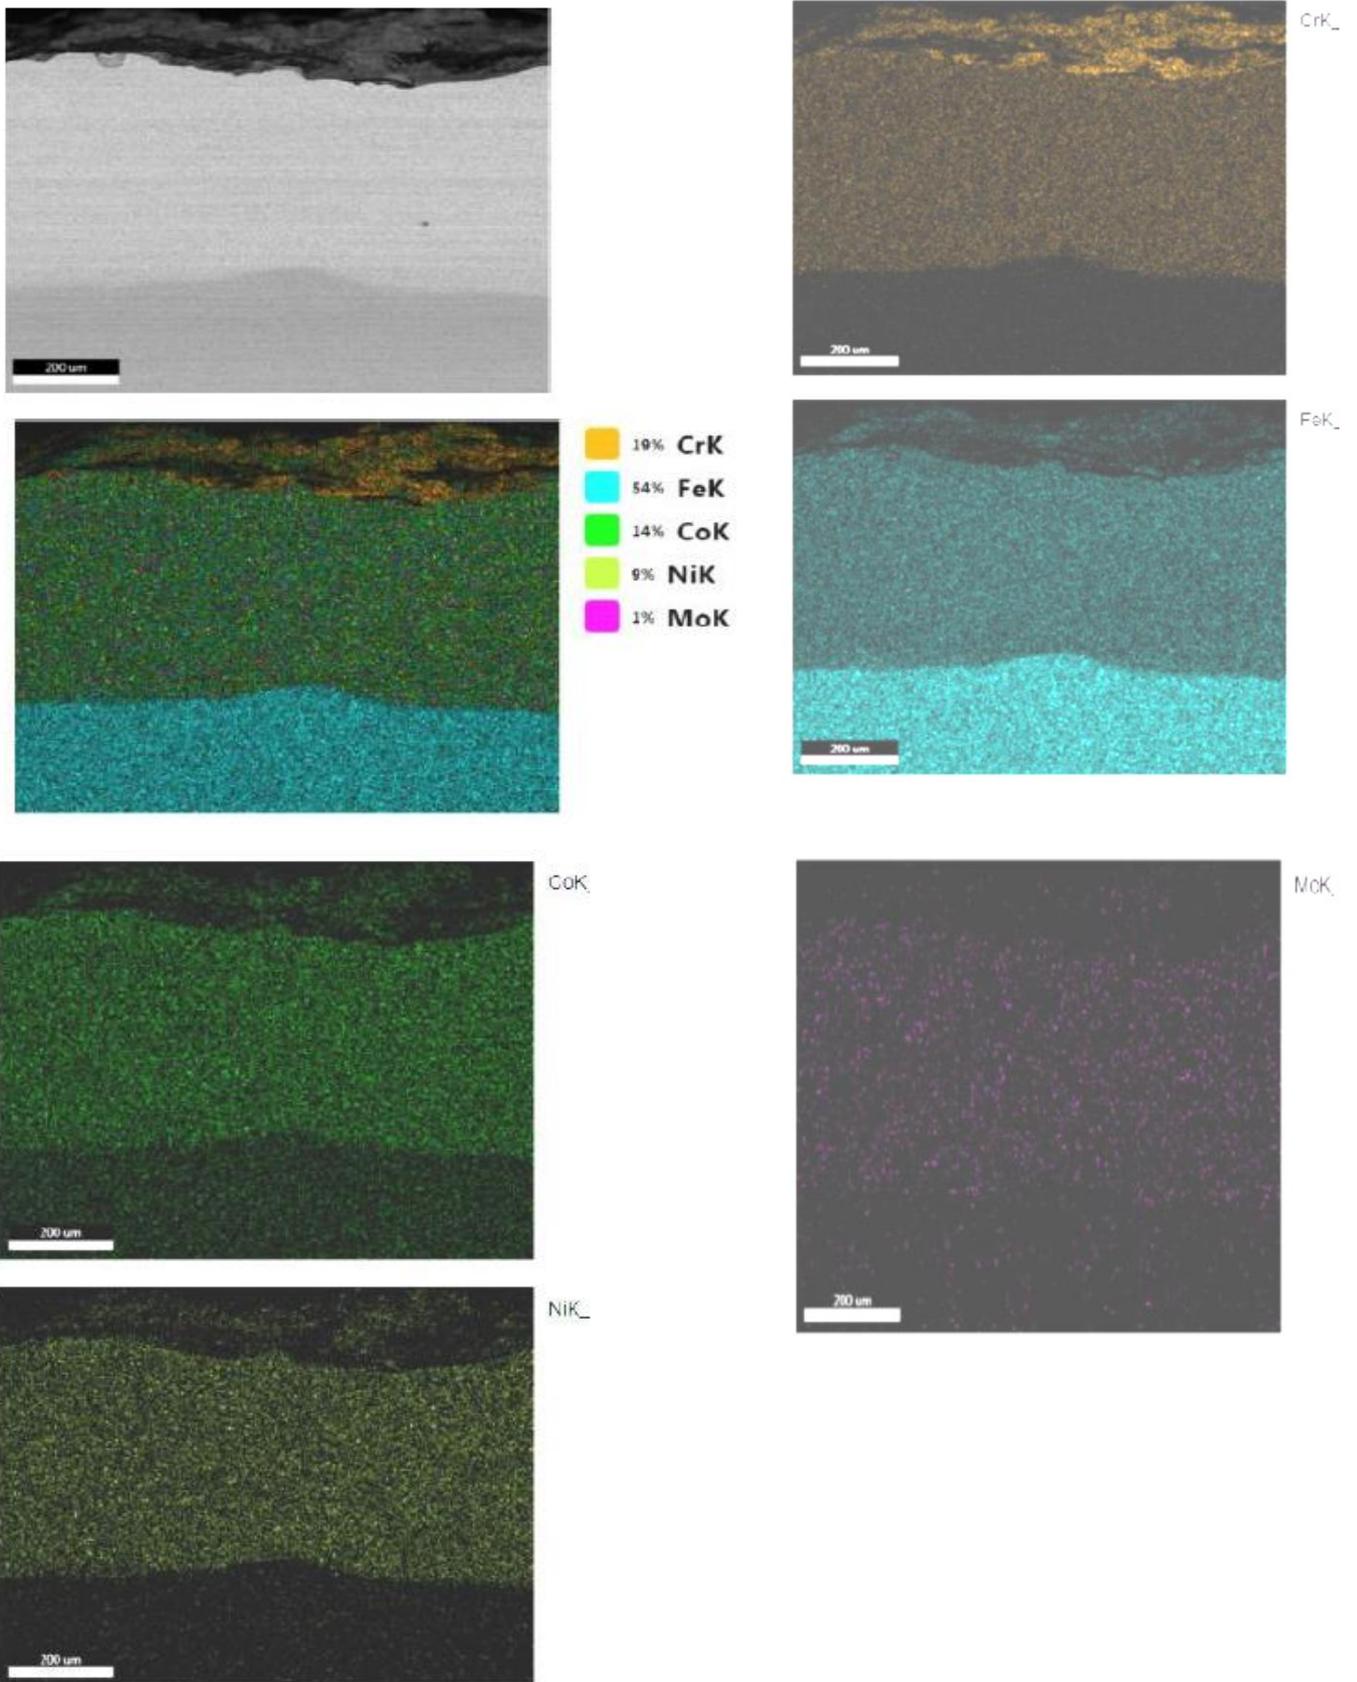
**Figure 38:** SEM and EDX general analysis showing X-ray mapping for LC-HEA2-HT2 elements and identification of disperse deposition of elements.

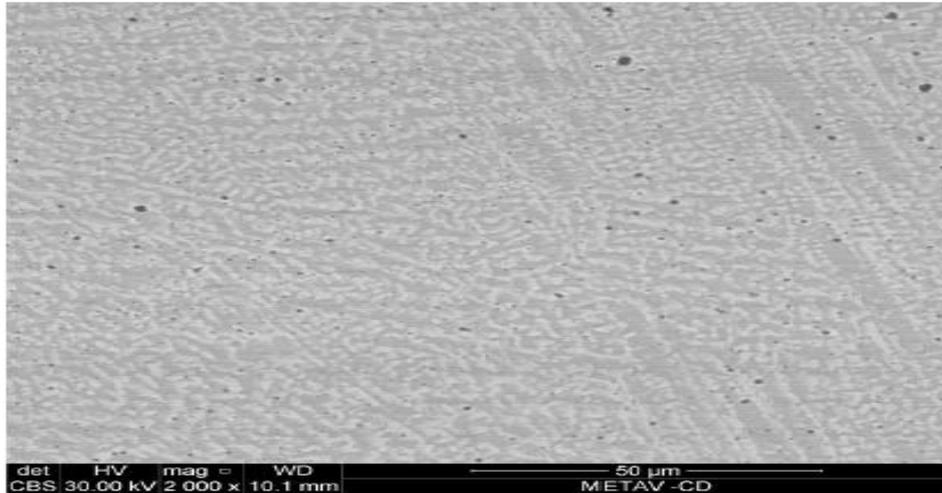
**Figure 39:** Back scattering image (CBS) for composition of LC-HEA2-HT2 alloy on the coating. Aspect of the general microstructure of the clad HEA treated alloy on coating.

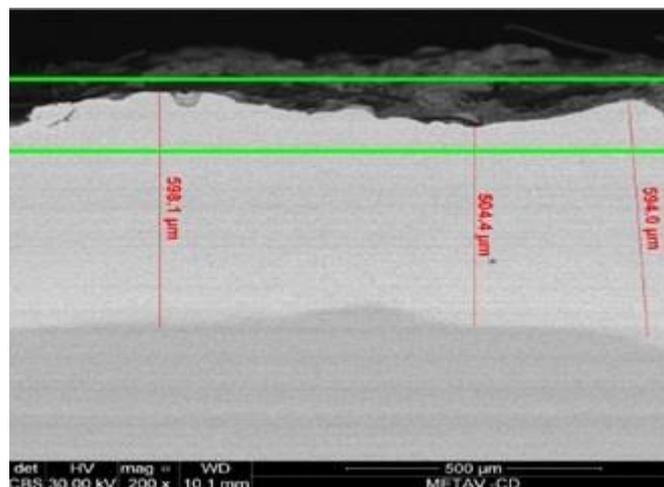
**Figure 40:** The micrograph shows the LC-HEA2 sample in cross-section and indication of the area for TEM lamella preparation.

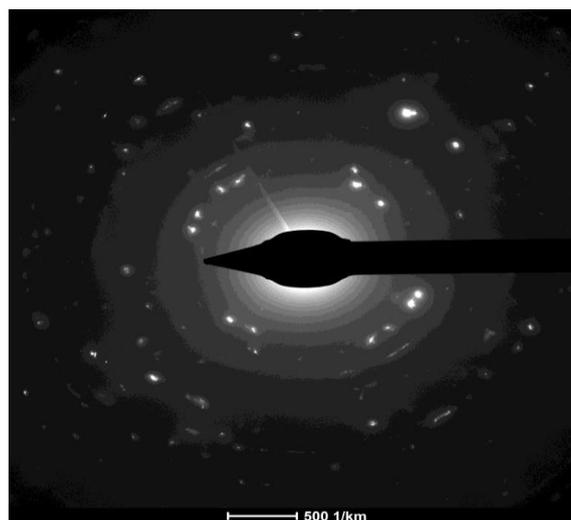
**Figure 42:** Selected area diffraction patterns (SAED) of deposition show the presence some rings from the fine grained  $\text{Cr}_2\text{O}_3$  particle formatted as surface deposition of LC-HEA2-HT2 layer.

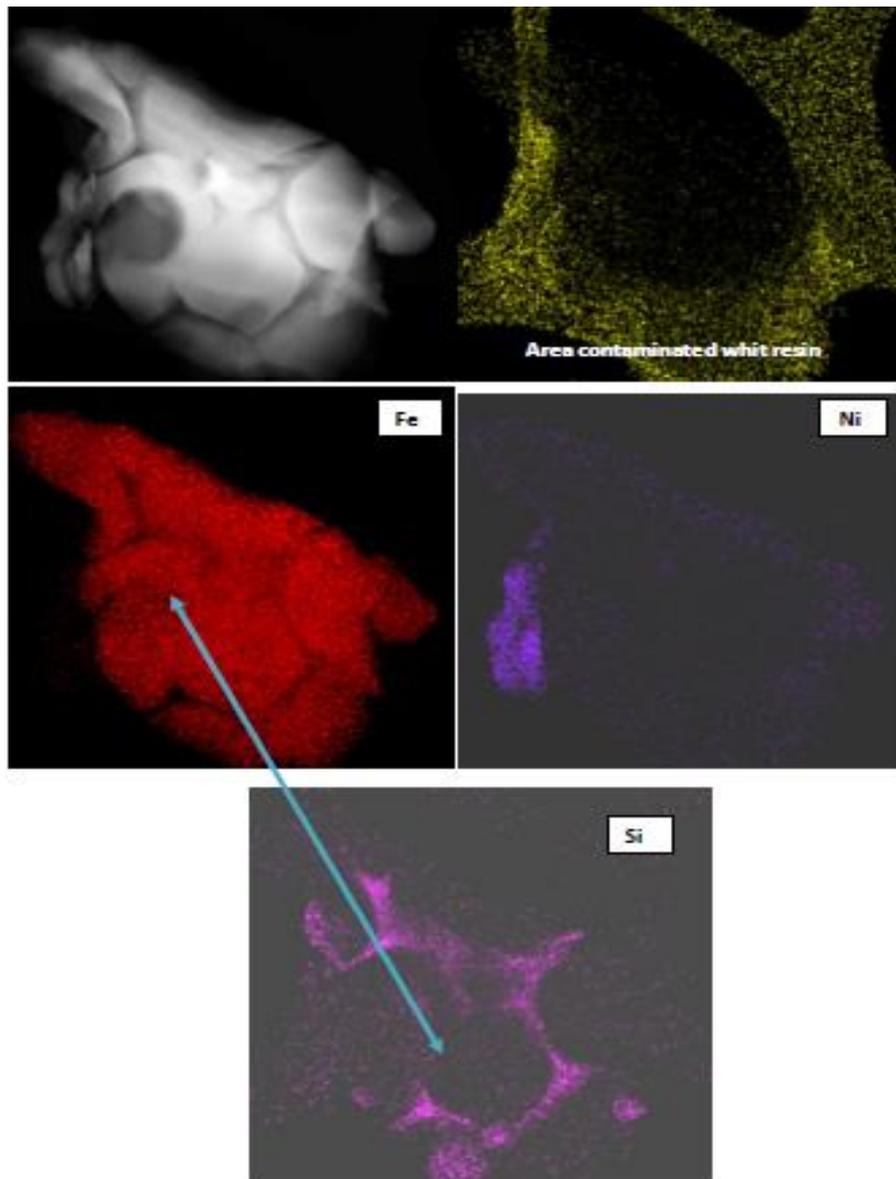
**Figure 43:** TEM mapping of LC-HEA2-HT2 specimen showing element distributions (Fe, Ni). Note a inter crystalline Si particle with high content of Si possibly due by contamination by the lacquer employed to protect the un-coated areas of the specimen from corrosion.
